**Coastal Protection and Restoration
Authority of Louisiana (CPRA)**

2016/2017 Annual Inspection Report

HWY 384 HYDROLOGIC RESTORATION PROJECT (CS-21)

March 23, 2017
Cameron Parish

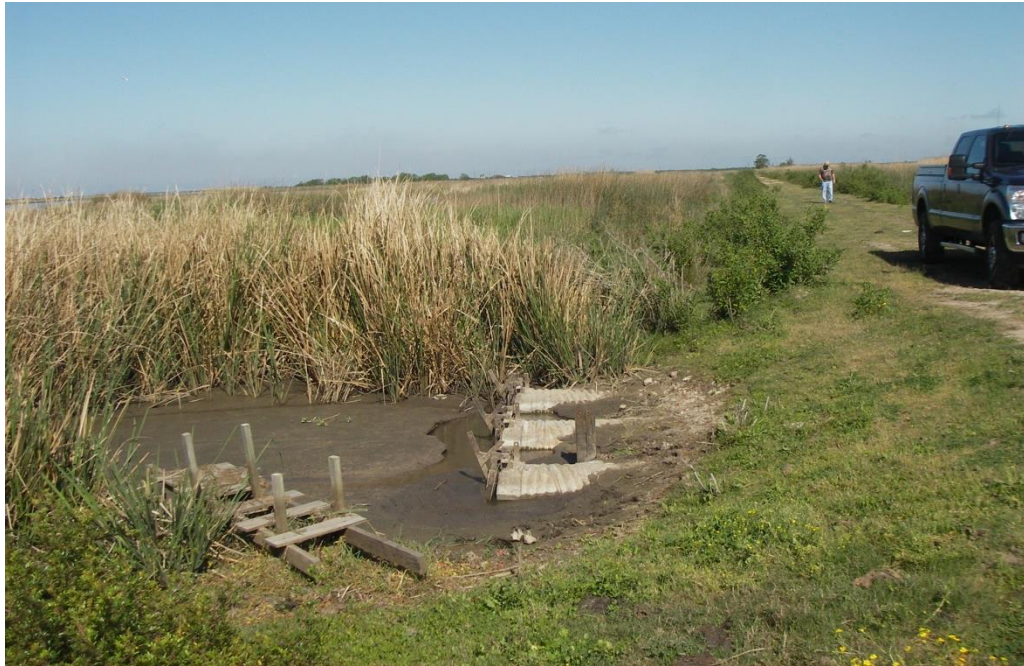
Photo No. 1, Structure No.1, Project Interior

The structure and inlet channel are in good condition. The inlet channel which was dredged in 2015 is still supplying freshwater to the structure; however, sediment has deposited around the hyacinth fence, the culvert inlets and on the project interior adjacent to the structure. The collection of sediment has restricted the flow through the culverts and prevents the flaps from opening properly. Currently limited flow is passing through two of the three culverts. Flow can be restored by cleaning out adjacent to the structure to allow the flaps to operate as intended.

To continue to perform as intended, minor maintenance is needed to clear sediment and debris from the vicinity of Structure No. 1. This would restore flow into the project.

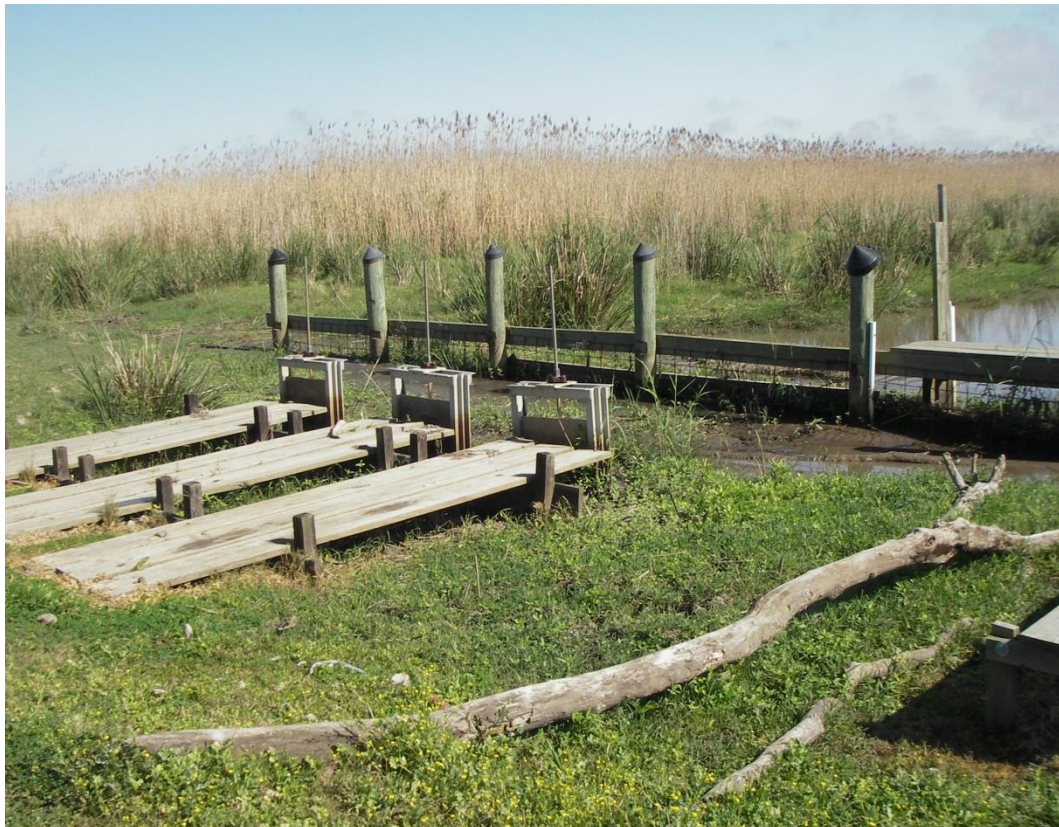
Photo No. 2, Structure No.1, Inlet Channel, Hyacinth Fence and Operations Equipment

The board walkways are in good conditions since being replaced. An ever increasing amount of vegetation has established itself on the inside of the project area near Structure No. 1. There is evident submerged vegetation in the cove north of the structure. (See Appendix B, Photos 1-4)

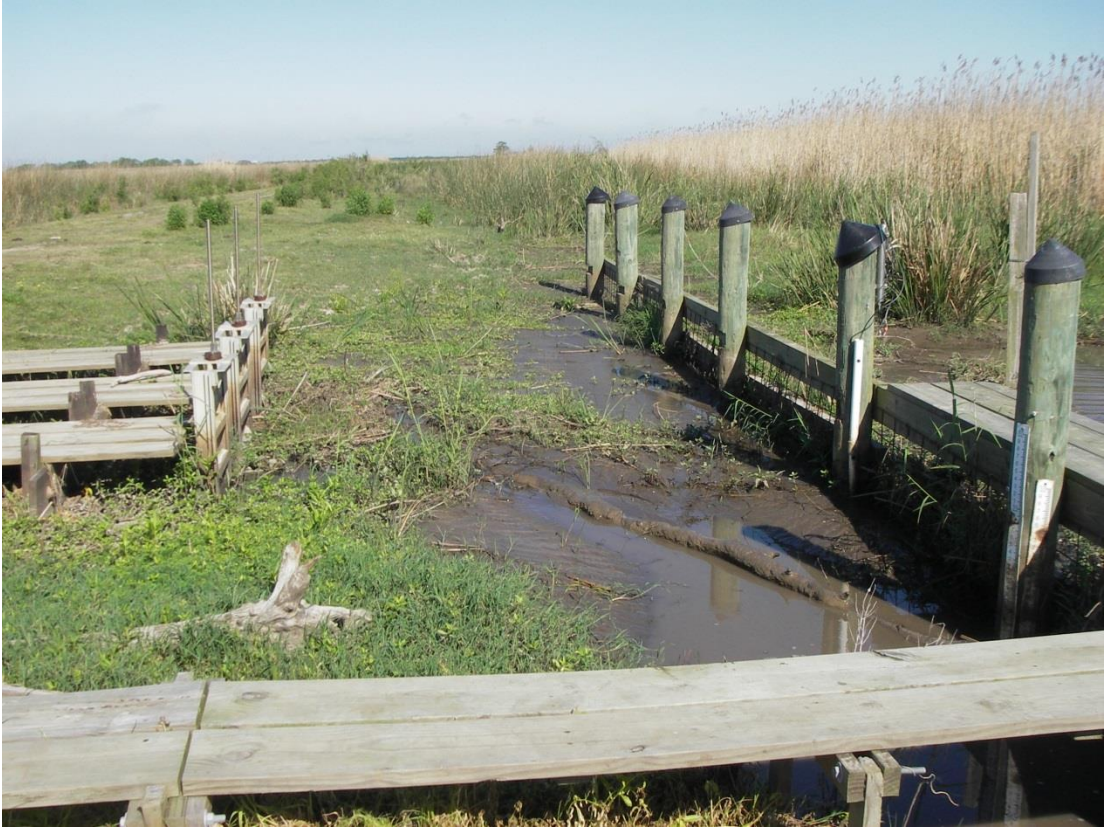
Photo No.3, Structure No.1, Culverts - Sediment

Item	Condition	Physical Damage	Corrosion	Photo #	Observations and Remarks
Steel Bulkhead / Caps	N/A				
Flapgates/Outlet Pipe	Fair			1	Sediment has restricted the flapgates from opening all the way.
Inlet Channel	Good			2&4	Inlet channel is in good condition after the 2015 dredging project; however, sediment has collected adjacent to the hyacinth fence, and culverts
Hardware/Sluiceways	Good			2	All gates are open but only two are partially flowing water due to sediment against the structure
Hyacinth Fence	Good			2-4	Sediment, debris and vegetation is accumulating since the 2015 maintenance event.
Timber Piles	Good			2-4	
Timber Wales	N/A				
Plastic Pile Caps	Good			2 & 4	pile caps are in place
Cables	N/A				
Signage /Supports				1 & 2	Staff Gauges were replaced on the inlet and outlet side in 2014 with reference to NAVD88 Geoid12A
Staff Gauges	Good				
Rip Rap embankment	Good				
InSitu AquaTroll 200 - 29r	Good			2	Telemetry has been replaced with a 300R tube unit and ATT 3G services. Sonde was not operational due to sediment around it.

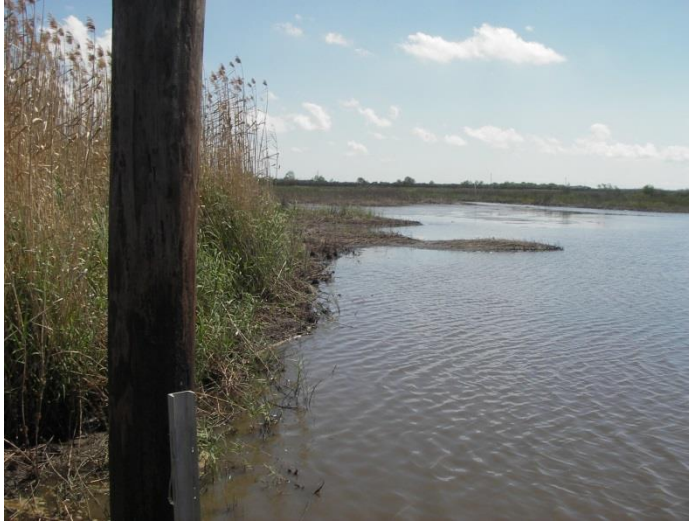
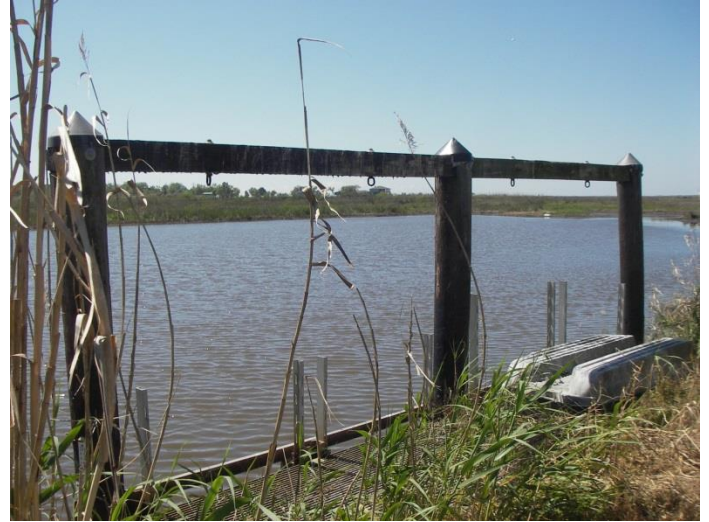
Photo No. 5, Structure No. 12, Inlet Side

The structure is in good condition. The water level was very low. The staff gauge read -0.6ft on the inside and -0.7ft on the inside. The vegetation on the terraces was plentiful and expanding. The board walkways were in good condition. (Appendix B, Photos 5&6)

Item	Condition	Physical Damage	Corrosion	Photo #	Observations and Remarks
Steel Bulkhead / Caps	N/A				
Steel Grating	Good			5	
Stop Logs	Good			5	
Hardware/Flapgates	Good			6	
Timber Piles	Good			5	
Timber Wales	N/A				
Plastic Pile Caps	Good			5 & 6	Plastic pile caps were in place.
Cables	N/A				
Staff Gages	Fair			5 & 6	Staff gauges on the inlet and outlet side were replaced in 2014 to the GEOID 12A datum.
Rip Rap embankment	Good			5 & 6	Embankment was in good condition.
InSitu AquaTroll 200 - 15r	Good				The telemery equipment has been upgraded to a 300R tube unit with ATT 3G service.
Access Roadway	Good				The access road was in good condition. New limestone was placed in sections on the road by others, possibly due to monitoring well work in the project area and use of the road for access.

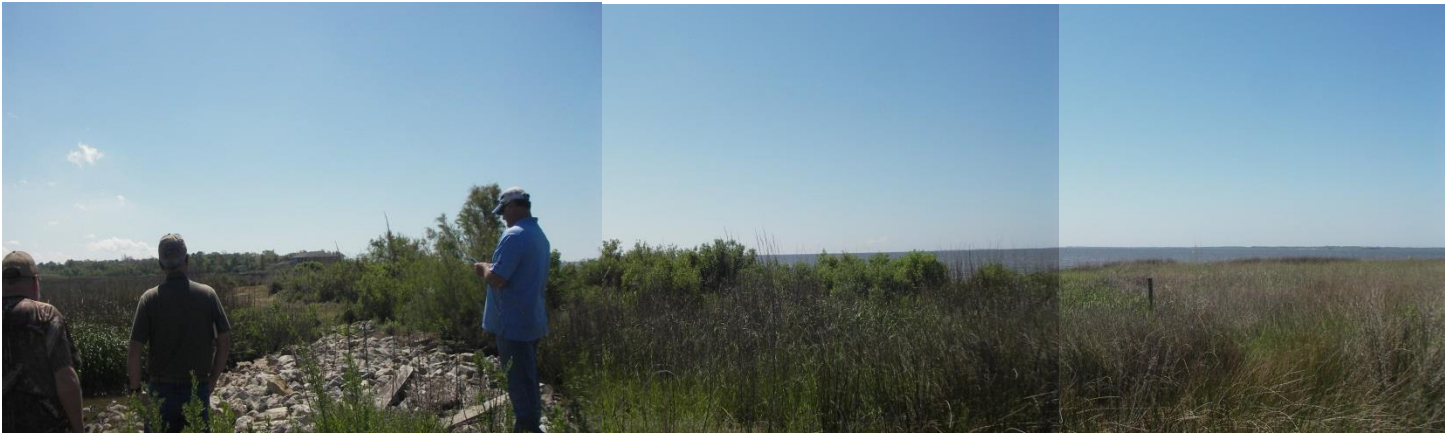
Photo No. 7, Structure No. 8, Rock Plug Looking South towards lake

The rock plug was in excellent condition. Vegetation has expanded along the rock plug on the lake side and on the interior. Open water in the marsh interior can no longer be seen from the rock plug. (Appendix B, Photos 7&8)

Item	Condition	Physical Damage	Corrosion	Photo #	Observations and Remarks
Steel Bulkhead / Caps	N/A				
Steel Grating	N/A				
Stop Logs	N/A				
Hardware	N/A				
Timber Piles	N/A				
Timber Wales	N/A				
Galv. Pile Caps	N/A				
Cables	N/A				
Signage /Supports	N/A				no longer necessary
Staff Gages					
Rip Rap (plug)	Good			7 & 8	The rock plug is in tact and vegetation has expanded along the plug on the lake side. Besides the small channel there is no longer any open water visible from the plug in the project interior.
Earthen Embankment

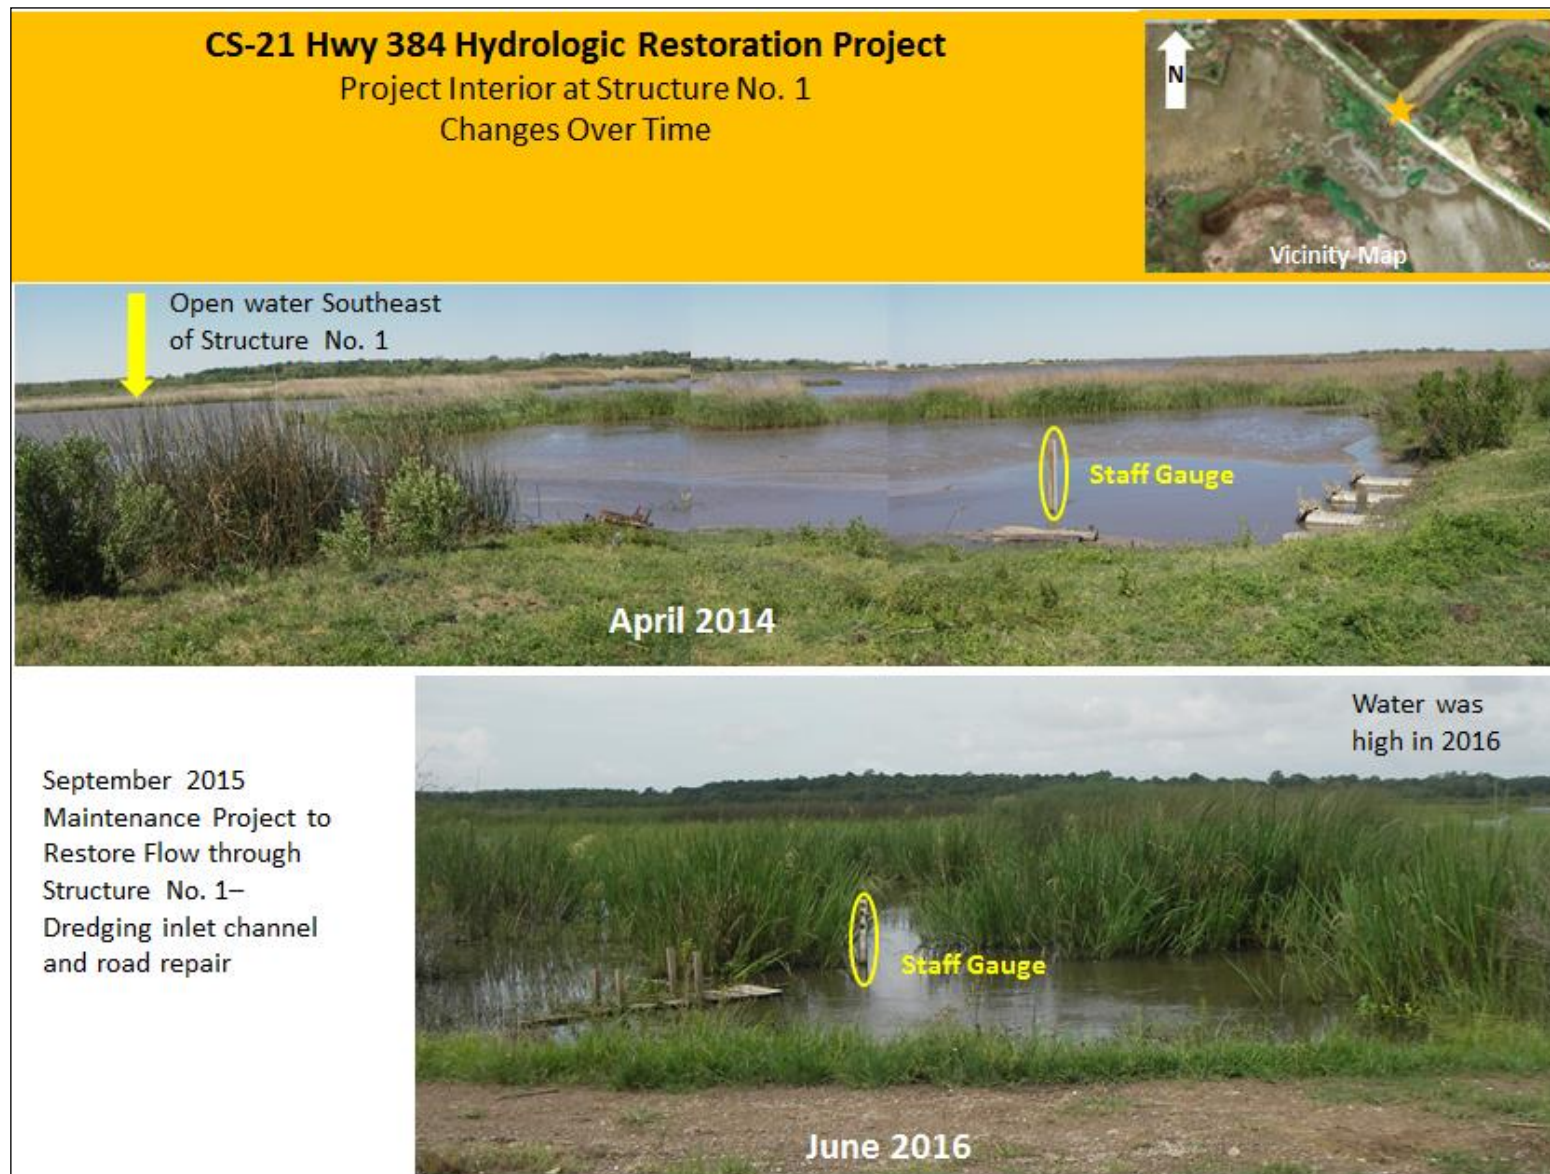
Photo No. 9, Vegetation Changes Over Time (2014- 2016): Project Interior –Structure No.1

Overall, the Hwy. 384 Hydrologic Restoration Project is in good condition and functioning as designed. The expansion of vegetation within the project has been prevalent and has spread into areas which were visibly open water during the previous inspection. Particularly, this can be seen in the vicinity of Structure No. 1 where sediment has deposited and new vegetation has taken hold over the last year. (Appendix B, Photos 9-11) Dredging of the inlet channel in 2015 and restoring the flow into the project had a major impact on the changes seen.

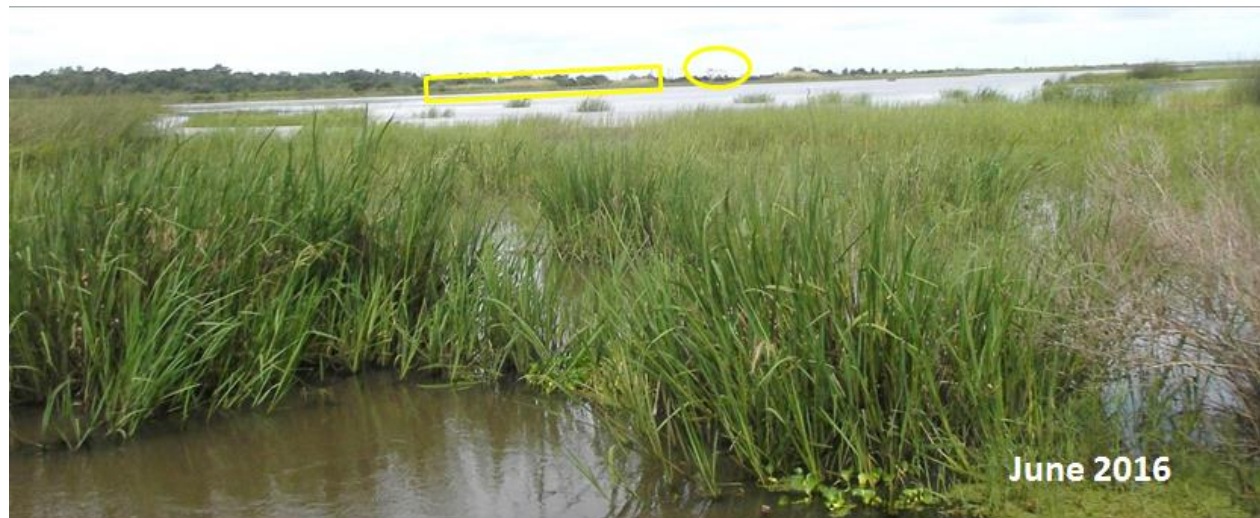
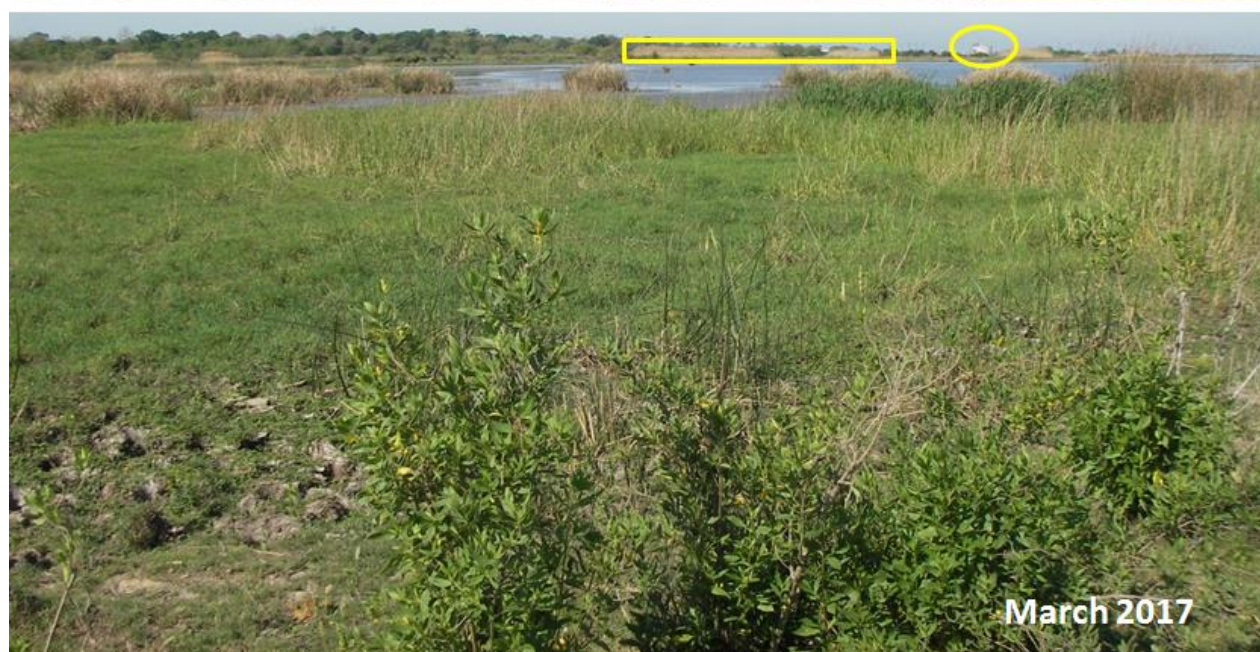
Photo No. 12, Vegetation Changes Over Time (2017): Project Interior – Northwest of Structure No. 1

Project Interior
taken Northwest
of Structure No.
1 on levee road.

Water was high in
2016 and low in
2017 but the
changes in the
marsh elevation
are still evident.
